The Sands  
Mechanical  
Museum

### Indicator Lens fix

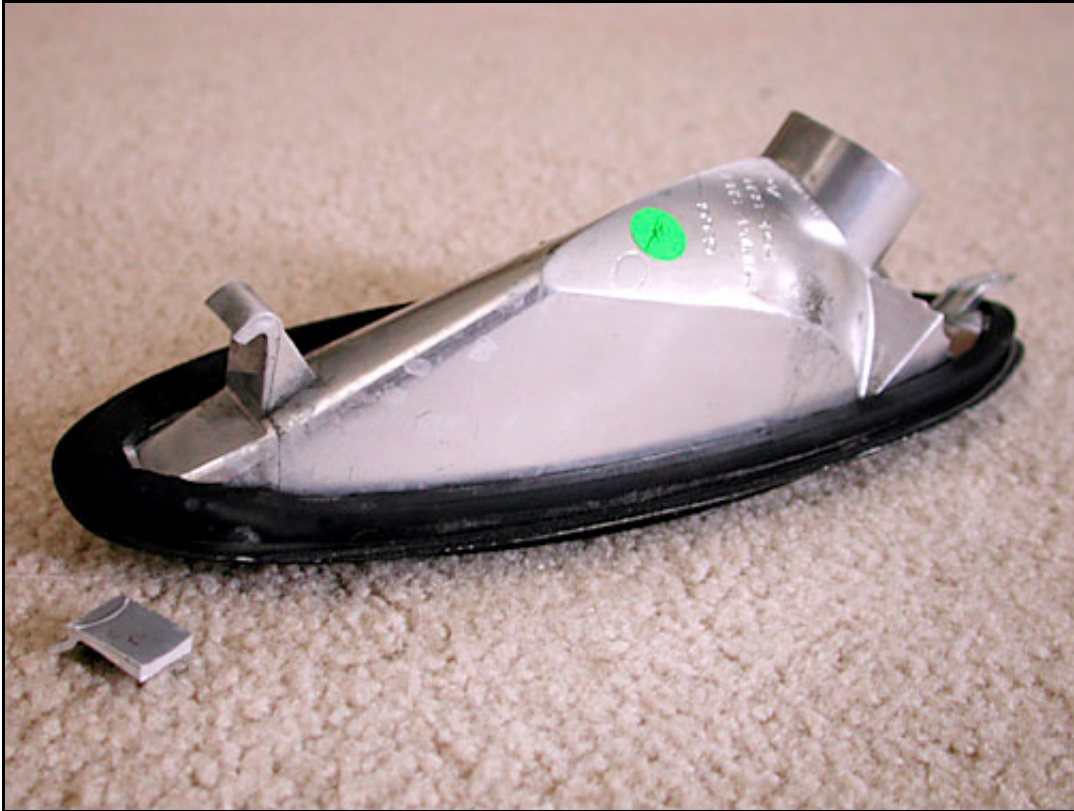
The retaining tab on the front indicator (turn signal) lens may be under stress while mounted in the front clam. If it breaks off, the indicator lens will pop out and hang around bumping on the front clam, retained by the wire to the lamp.

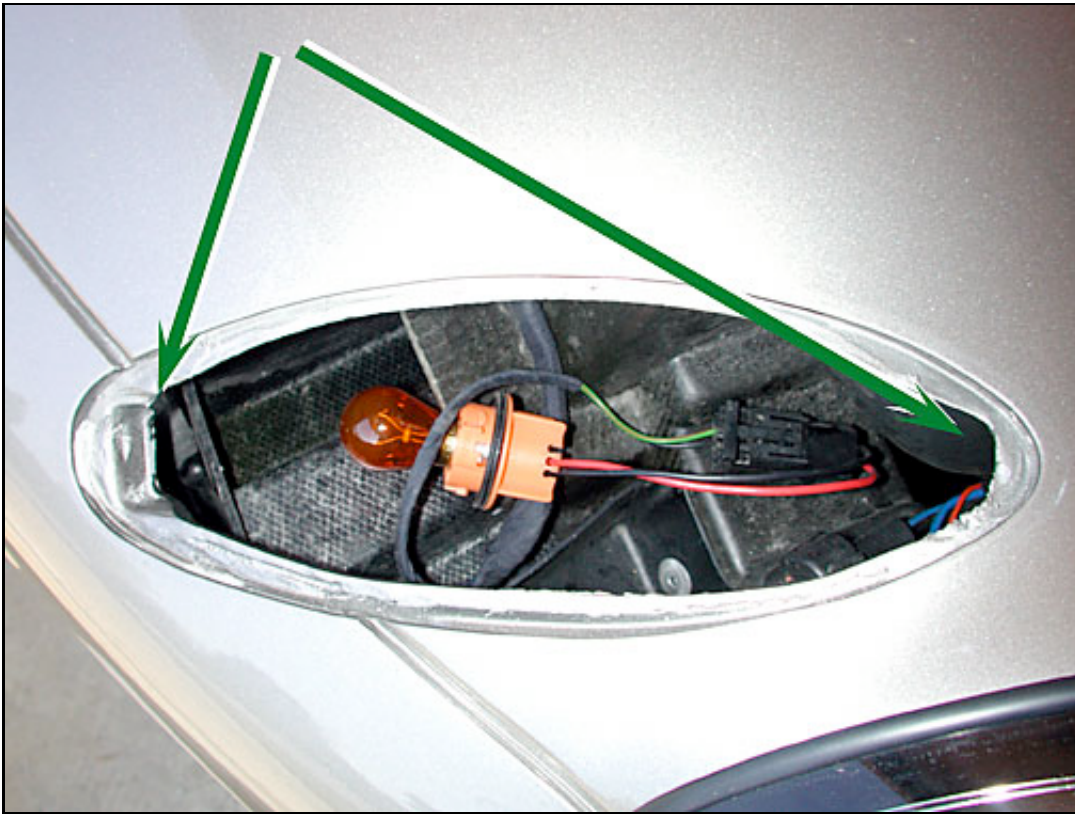
The apparent cause is the short distance between the two points marked by the green arrows, the distance between the top and bottom of the opening. If this distance is too short, it will keep the plastic retaining tab under constant stress and the vibration of driving will cause the tab to eventually fail.

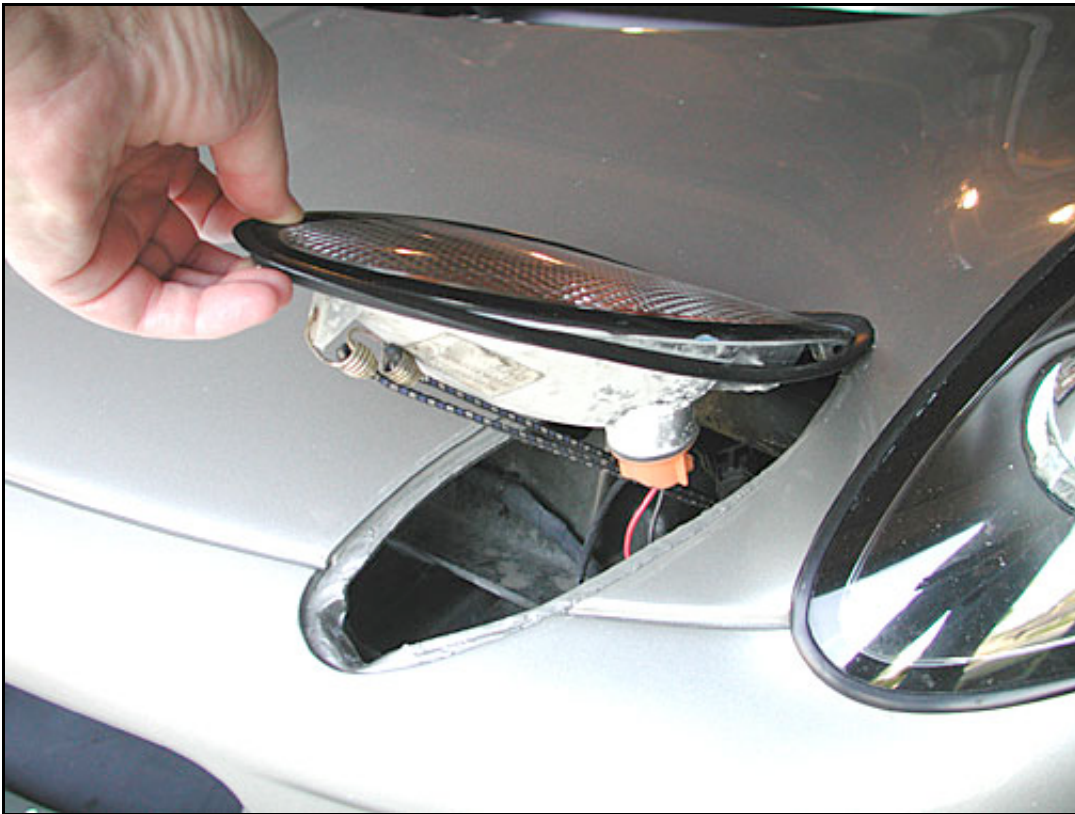
It appears the opening is trimmed by hand, with a real person grinding down the perch for the lens tab and hook. In the above picture, it appears the left perch is not trimmed sufficiently. Look closely at the bright land, a narrow highlighted portion just at the tip of the left arrow.

It is possible to slightly enlarge the opening and use a replacement lens with an unbroken tab.

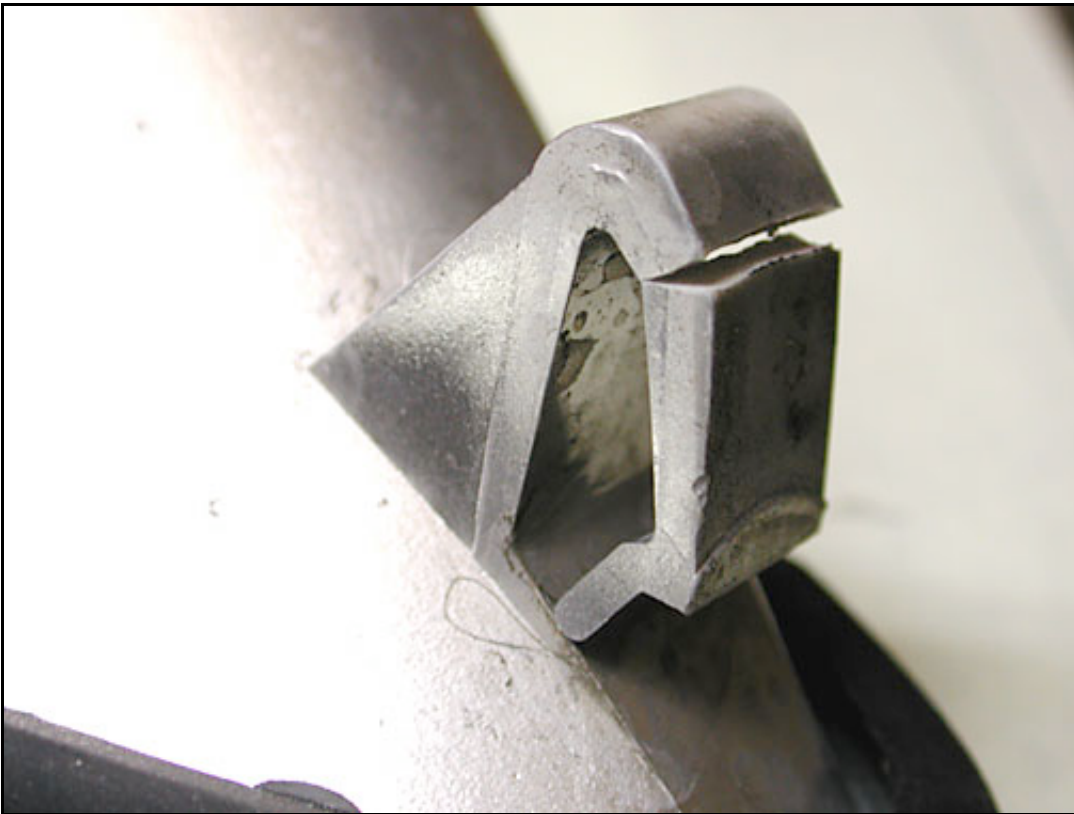
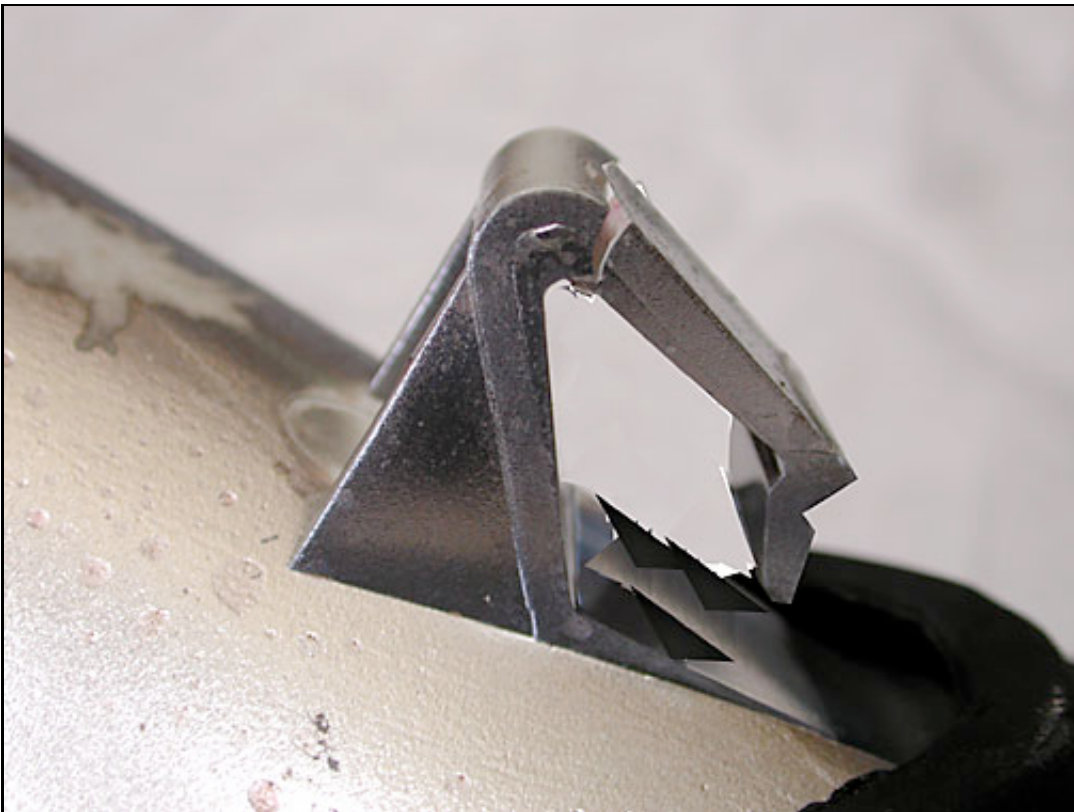
The piece of spring steel is bolted to the remaining portion of the tab. A hack saw blade can be used. The angles of the bend approximate the shape of the original tab. In order to demonstrate the shape, the image below show a broken tab and an altered image with the broken portion rotated into place. It appears the front lip of the clam opening fits into the slight V at the tip of the retaining tab.

I finally fixed mine by drilling a hole in the remaining portion of the tab and connecting a bungee cord (rubber cargo strap) and feeding the cord inside the clam to an available loop. I can just lift on the front edge of the indicator lens and the lens will come up enough to reach inside to release the cord.
